**ASBESTOS REGISTER
NTB - 00339
BORROLOOLA ACCOMMODATION COMPOUND
NORTHERN TERRITORY**

AEC Environmental Pty Ltd
Date: September 2013
Register No: NT0587

AEC Environmental Pty Ltd (AEC) was contracted by the Department of infrastructure (“the client”) to compile this Asbestos Register for Lot 379, Asset Number NTB-00339 Borroloola, NT.

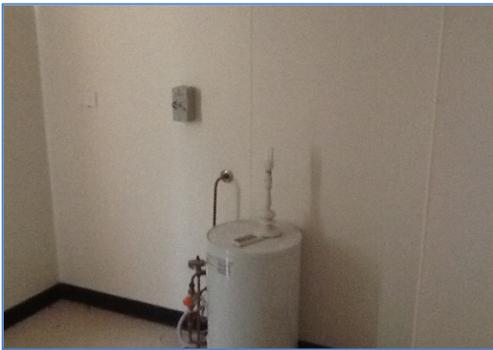
| Location | Type of Material | | |
|---|---|---|---|
| 1. Wall lining in 'A1' bedroom, only south elevation wall (6m ²) | Fibre cement sheet material containing white (Chrysotile) asbestos (sample no.2) | | |
| Non friable | Stable | Install 1 small warning signs | Low |

| LOCATION | SAMPLE I/D NO. | LABORATORY RESULTS |
|---|---|---|
| Wall lining in 'A1' bedroom, only south elevation wall (6m ²) | No.2 | White (Chrysotile) asbestos |

| Location | Type of Material | | |
|---|---|---|---|
| Refer to Asbestos Management Plan & Section 7.0: Policies and Recommendations | | | |

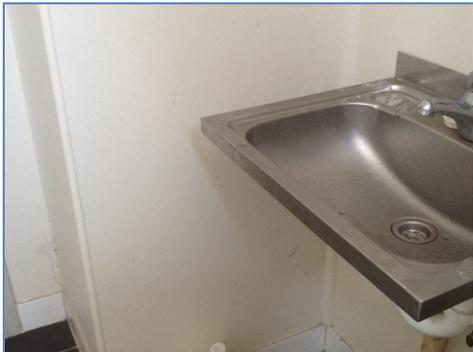
| Location | Type of Material | | |
|---|---|---|---|
| 2. Wall lining in 'A3' bathroom, section to left hand side of sink (floral pattern under paint) (2m ²) | Fibre cement sheet material containing white (Chrysotile) asbestos (sample no.3) | | |
| Non friable | Stable | Install 1 small warning signs | Low |

| LOCATION | SAMPLE I/D NO. | LABORATORY RESULTS |
|---|---|---|
| Wall lining in 'A3' bathroom, section to left hand side of sink (floral pattern under paint) (2m ²) | No.3 | White (Chrysotile) asbestos |

| Location | Type of Material | | |
|---|---|---|---|
| Refer to Asbestos Management Plan & Section 7.0: Policies and Recommendations | | | |

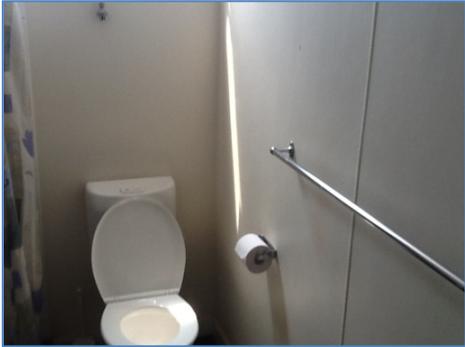
| Location | Type of Material | | |
|---|---|---|---|
| 3. Wall lining in 'A3' bathroom, South and East elevation walls. (6m ²) | Fibre cement sheet material containing white (Chrysotile) asbestos (sample no.4) | | |
| Non friable | Stable | Install 2 small warning signs | Low |

| LOCATION | SAMPLE I/D NO. | LABORATORY RESULTS |
|---|---|---|
| Wall lining in 'A3' bathroom, South and East elevation walls. (6m ²) | No.4 | White (Chrysotile) asbestos |

| Location | Type of Material | | |
|---|---|---|---|
| Refer to Asbestos Management Plan & Section 7.0: Policies and Recommendations | | | |

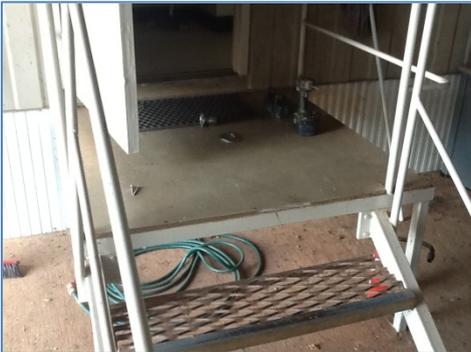
| TRANSPORTABLE ONE – External | | | |
|---|---|---|---|
| 4. Landing at top of stairs – entry to unit 'A4'. (2m ²) | Fibre cement sheet material containing white (Chrysotile) asbestos (sample no.6) | | |
| Non friable | Poor | Install 1 small warning signs | Low |

| LOCATION | SAMPLE I/D NO. | LABORATORY RESULTS |
|---|---|---|
| Landing at top of stairs – entry to unit 'A4'. (2m ²) | No.6 | White (Chrysotile) asbestos |

| TRANSPORTABLE ONE – External | | | |
|---|---|---|---|
| Refer to Asbestos Management Plan & Section 7.0: Policies and Recommendations | | | |

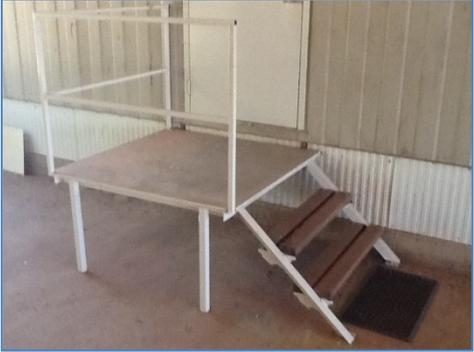
| Location | Type of Material | | |
|---|---|---|---|
| 5. Landing to both front and rear stairs –(2m ²) | Fibre cement sheet material containing white (Chrysotile) asbestos (per sample no.6) | | |
| Non friable | Poor | Install 2 small warning signs | Low |

| Location | Type of Material | | |
|---|---|---|---|
| Refer to Asbestos Management Plan & Section 7.0: Policies and Recommendations | | | |
