**ASBESTOS REGISTER
NTB-00403
GREATOREX BUILDING
ALICE SPRINGS
NORTHERN TERRITORY**

**Department of Infrastructure
PO Box 61, Palmerston NT 0831**

**AEC Environmental Pty Ltd
Date: May 2013
Register No: NT0545**

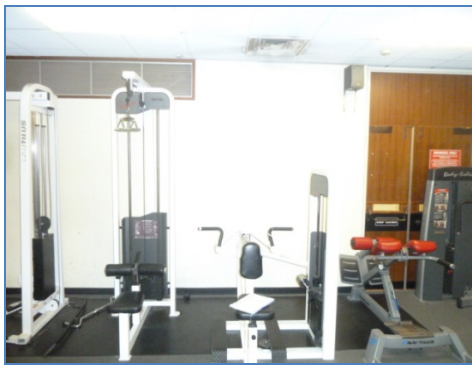
Location	Type of Material	Condition	
1. Wall lining to Northern wall (60m ²)	Fibre cement sheet material containing white (Chrysotile) asbestos (sample no.1)	Stable

Recommendation and Action			
Warning signs: 4 small signs Refer Section 7.0: Management Procedures.
