**ASBESTOS REGISTER
NTB 00636
DEPARTMENT OF INFRASTRUCTURE
REGIONAL OFFICE
NHULUNBUY NT**

**AEC Environmental Pty Ltd
Date: July 2013
Register No: NT0560**

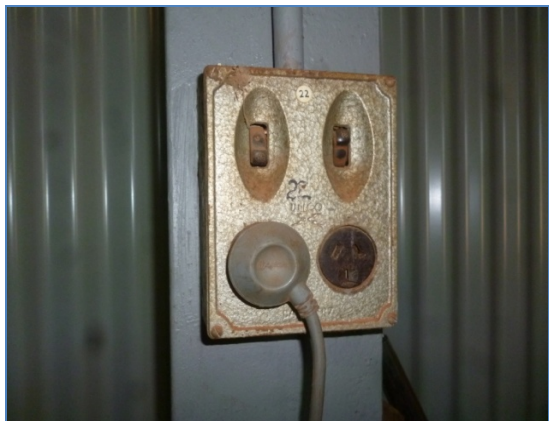
1. Beam mounted power outlet in Test shed – 2 beams Eastern wall (1m^2)		Not accessed or sampled. Based on past experiences in similar areas, asbestos in some form may exist. It is recommended that if work is contemplated in this area, due care and diligence should be exercised	
Recommendation and Action			
Refer to Asbestos Management Plan & Section 7.0: Policies and Recommendations			
Situational Asbestos Risk Assessment			
Friability	Condition	Signage	Risk Rating
Friable		1 Small sign	Low

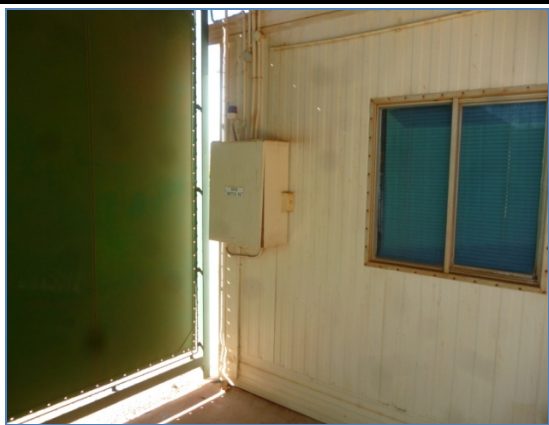
2. Main switch board - Social club – Northern elevation		Electrical Backing Board (Zelemite material) containing white (Chrysotile) asbestos (sample no.3)	
Recommendation and Action			
Refer to Asbestos Management Plan & Section 7.0: Policies and Recommendations			
Situational Asbestos Risk Assessment			
Friability	Condition	Signage	Risk Rating
Non friable	Some damaged sections	1 Small Sign	Low

LOCATION	SAMPLE I/D NO.	LABORATORY RESULTS
VOQ kitchen sink soundproofing (<1m ²)	No.1	No asbestos
Floor covering throughout Parks office (65m ²)	No.2	No asbestos
DOI Social Club Northern elevation main switch board (<1m ²)	No.3	White (Chrysotile) asbestos
