**ASBESTOS REGISTER
NTB - 01005
CHAN BUILDING – STATE SQUARE
BENNETT STREET
DARWIN
NORTHERN TERRITORY**

**AEC Environmental Pty Ltd
Date: October 2012
Register No: NT0503
Register Version: NT0503/02**

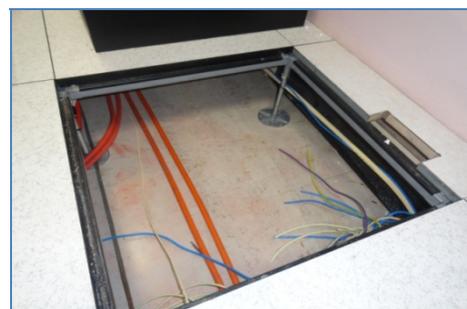
Location	Type of Material	Condition
1. Floor covering below floating floor throughout Northern end of Server Room, including Northern Office (550m ²)	White vinyl tiles & associated black adhesive containing white (Chrysotile) asbestos (sample no. 1)	Stable

Warning signs in place
Refer Section 6.0: Management Procedures.

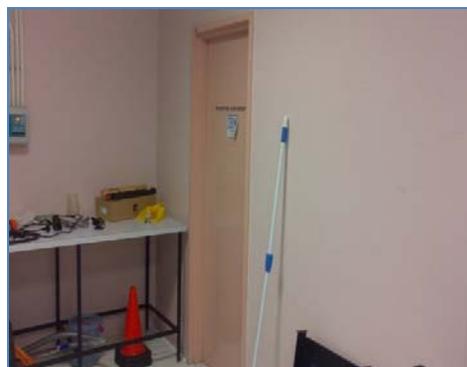
Location	Type of Material	Condition
2. Fire door, Northern Office (Office 6) (2m ²)	Not accessed or sampled. Based on past experience in similar areas, asbestos in some form may exist.	Stable Friable when exposed

It is recommended that if work is contemplated in this area, due care and diligence should be exercised
Warning signs in place
Refer Section 6.0: Management Procedures.

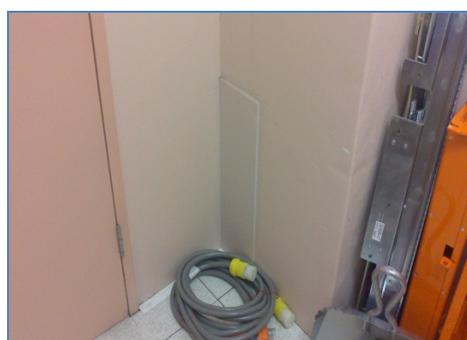
Location	Type of Material	Condition
3. Infill panel behind door within Northern Office (Office 6) (<1m ²)	Cement sheet material containing white (Chrysotile) asbestos (sample no. 2013-1)	Stable

Warning sign in place
Refer Section 6.0: Management Procedures.

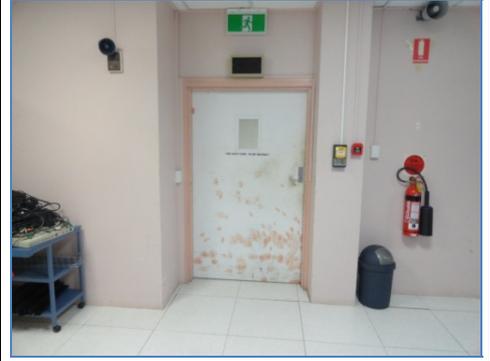
Location	Type of Material	Condition
4. Fire door, North East wall of Server room (2m ²)	Not accessed or sampled. Based on past experience in similar areas, asbestos in some form may exist.	Stable Friable when exposed
Recommendation and Action		
It is recommended that if work is contemplated in this area, due care and diligence should be exercised Warning signs in place Refer Section 6.0: Management Procedures.

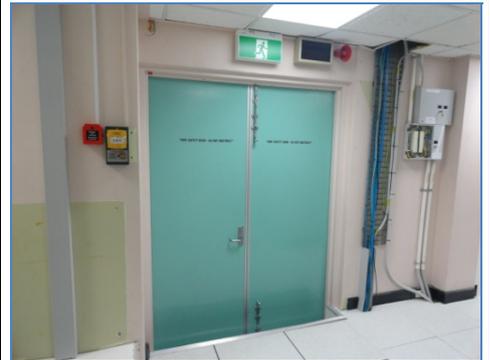
Location	Type of Material	Condition
5. Fire door, South East wall of Server room (4m ²)	Not accessed or sampled. Based on past experience in similar areas, asbestos in some form may exist.	Stable Friable when exposed
Recommendation and Action		
It is recommended that if work is contemplated in this area, due care and diligence should be exercised Warning signs in place Refer Section 6.0: Management Procedures.

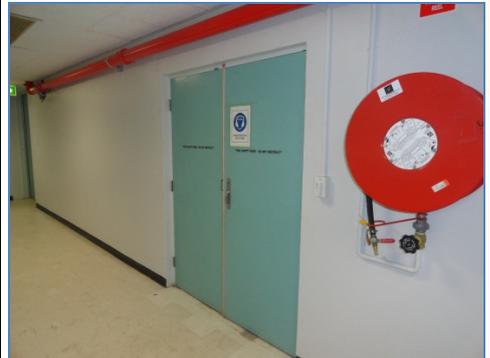
A/C PLANT ROOM		
Location	Type of Material	Condition
6. Fire door to west entrance (4m ²)	Not accessed or sampled. Based on past experience in similar areas, asbestos in some form may exist.	Stable Friable when exposed
Recommendation and Action		
It is recommended that if work is contemplated in this area, due care and diligence should be exercised Warning signs in place Refer Section 6.0: Management Procedures.

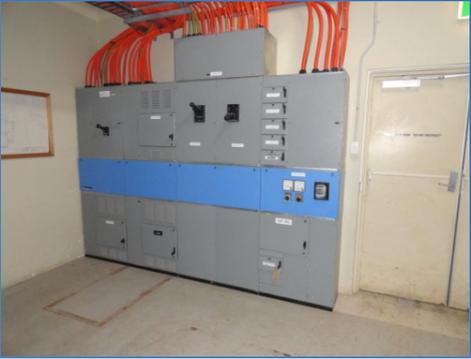
7. Switchboard unit, adjacent to West entrance (6m ²)	Not accessed or sampled. Based on past experience in similar areas, asbestos in some form may exist.	Stable	
<p>Recommendation and Action</p> <p>It is recommended that if work is contemplated in this area, due care and diligence should be exercised</p> <p>Warning signs in place</p> <p>Refer Section 6.0: Management Procedures.</p>

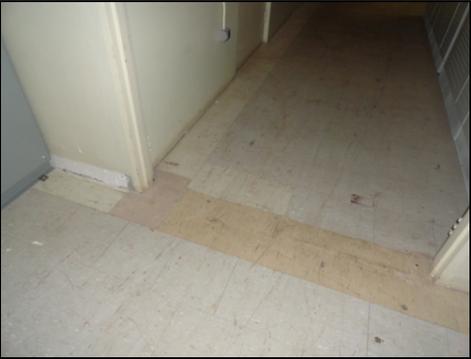
8. Floor covering throughout (50m ²) <i>Note: only the grey vinyl tiles contain asbestos.</i>	Grey vinyl tiles containing white (Chrysotile) asbestos (sample no. 4)	Stable	
<p>Recommendation and Action</p> <p>Warning signs in place</p> <p>Refer Section 6.0: Management Procedures.</p>

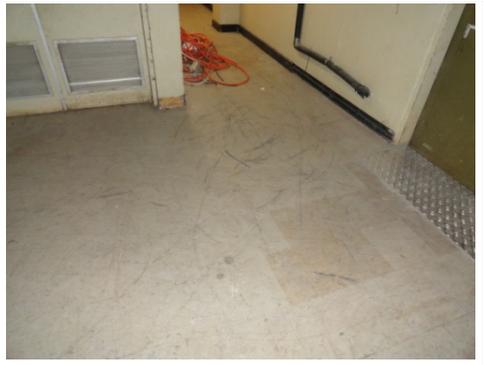
9. Floor covering to hallway, East of A/C Plant Room (30m ²)	Cream vinyl tiles containing white (Chrysotile) asbestos (sample no. 5)	Stable	
Recommendation and Action			
Warning signs in place Refer Section 6.0: Management Procedures.

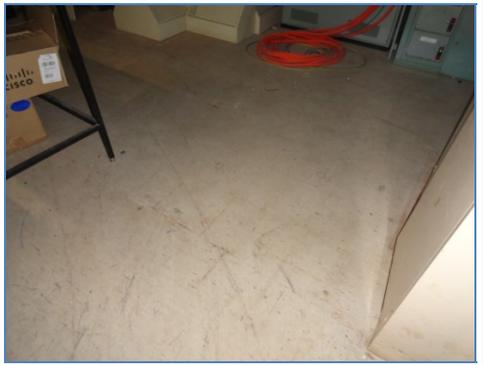
10. Floor covering throughout (25m ²)	Cream vinyl tiles containing white (Chrysotile) asbestos (per sample no. 5)	Stable	
Recommendation and Action			
Warning signs in place Refer Section 6.0: Management Procedures.

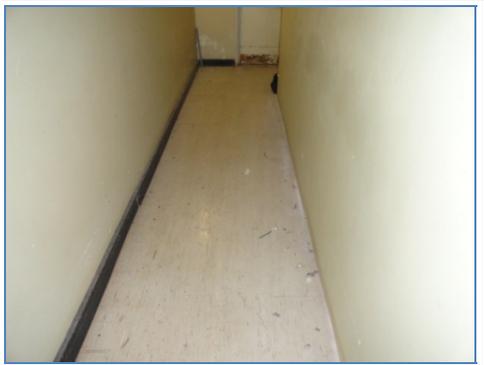
11. Floor covering to hallway between Electrical Storage / Switch Room & Northern staircase foyer (10m ²)	Cream vinyl tiles containing white (Chrysotile) asbestos (per sample no. 5)	Stable	
Recommendation and Action			
Warning signs in place Refer Section 6.0: Management Procedures.

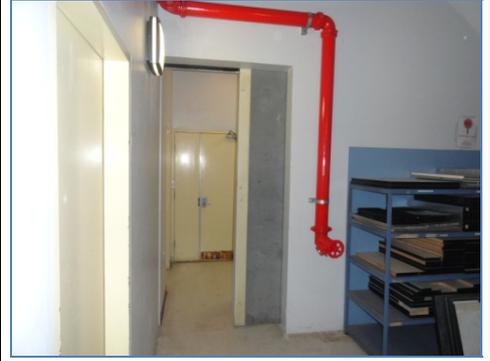
Location	Type of Material	Condition
12. Large sliding fire door (6m ²)	Not accessed or sampled. Based on past experience in similar areas, asbestos in some form may exist.	Stable Friable when exposed
Recommendation and Action		
It is recommended that if work is contemplated in this area, due care and diligence should be exercised Warning signs in place Refer Section 6.0: Management Procedures.

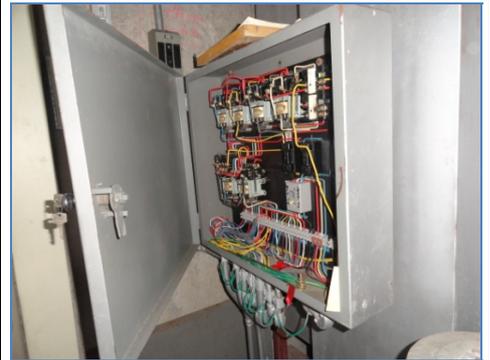
Location	Type of Material	Condition
13. Backing panel to switchboard in Dumb Waiter services riser (<1m ²)	Area accessed but not sampled. Based on findings in similar area, it is highly likely to contain asbestos.	Stable
Recommendation and Action		
Warning signs in place Refer Section 6.0: Management Procedures.		
NOTE: Limited access to brakes etc. within Dumb Waiter services riser

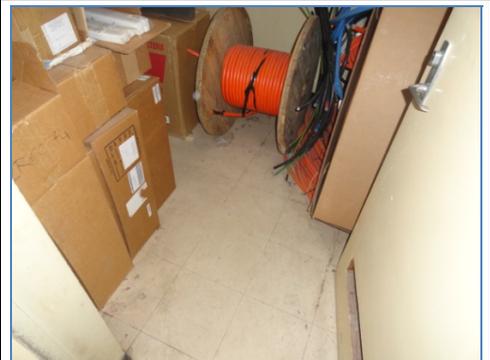
Location	Type of Material	Condition
14. Floor covering throughout "C.E" Room (12m ²)	White vinyl tiles & associated black adhesive containing white (Chrysotile) asbestos (per sample no. 1)	Stable
Recommendation and Action		
Warning signs in place Refer Section 6.0: Management Procedures.

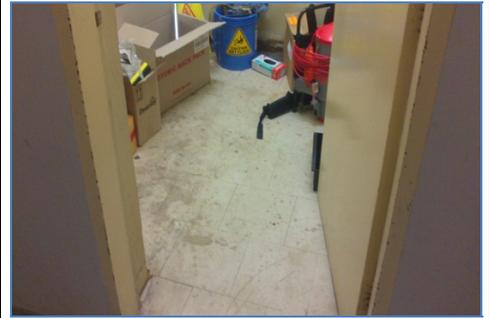
Location	Type of Material	Condition
15. Floor covering throughout Cleaners Store Room (5m ²)	White vinyl tiles & associated black adhesive containing white (Chrysotile) asbestos (per sample no. 1)	Stable
Recommendation and Action		
Warning signs in place Refer Section 6.0: Management Procedures.

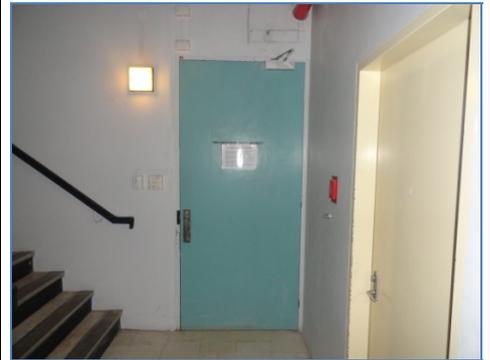
Location	Type of Material	Condition
16. Fire door adjacent to base of stairs (2m ²)	Not accessed or sampled. Based on past experience in similar areas, asbestos in some form may exist.	Stable Friable when exposed
Recommendation and Action		
It is recommended that if work is contemplated in this area, due care and diligence should be exercised Warning signs in place Refer Section 6.0: Management Procedures.

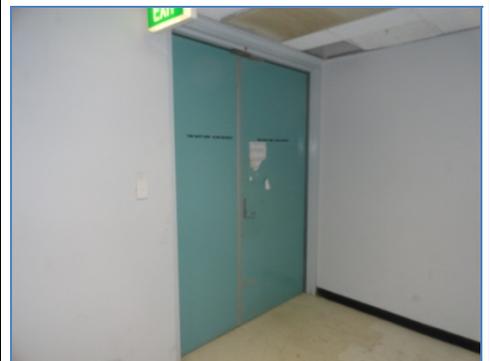
SOUTHERN STAIRCASE FOYER AREA		
Location	Type of Material	Condition
17. Fire doors (x2 sets), East entrance and entrance to Plant Room (6m ²)	Not accessed or sampled. Based on past experience in similar areas, asbestos in some form may exist.	Stable Friable when exposed
Recommendation and Action		
It is recommended that if work is contemplated in this area, due care and diligence should be exercised Warning signs in place Refer Section 6.0: Management Procedures.

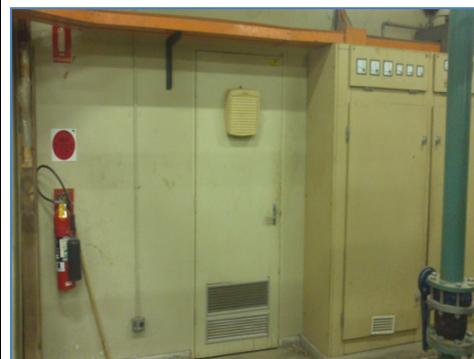
MAIN PLANT ROOM		
Location	Type of Material	Condition
18. Fire door, North East side of Plant Room (2m ²)	Not accessed or sampled. Based on past experience in similar areas, asbestos in some form may exist.	Stable Friable when exposed
Recommendation and Action		
It is recommended that if work is contemplated in this area, due care and diligence should be exercised Warning signs in place Refer Section 6.0: Management Procedures.

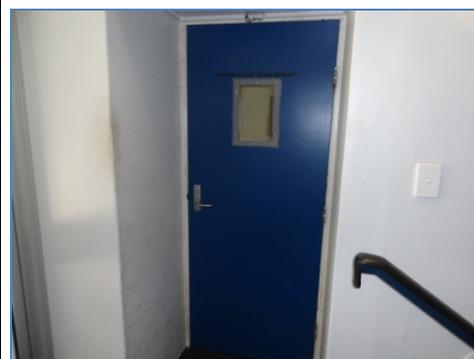
INTERNAL – GROUND LEVEL		
DATA CENTRE		
Location	Type of Material	Condition
19. Fire door, West entrance of Data Centre (2m ²)	Not accessed or sampled. Based on past experience in similar areas, asbestos in some form may exist.	Stable Friable when exposed
Recommendation and Action		
It is recommended that if work is contemplated in this area, due care and diligence should be exercised Warning signs in place Refer Section 6.0: Management Procedures.

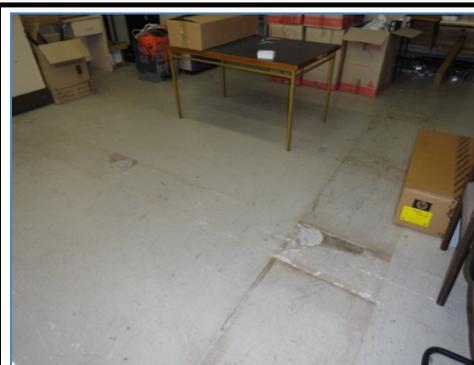
Location	Type of Material	Condition
20. Floor covering throughout Storage Room off kitchen in Data Centre office area (130m ²)	Grey vinyl tiles containing white (Chrysotile) asbestos (sample no. 12)	Stable
Recommendation and Action		
Warning signs in place Refer Section 6.0: Management Procedures.

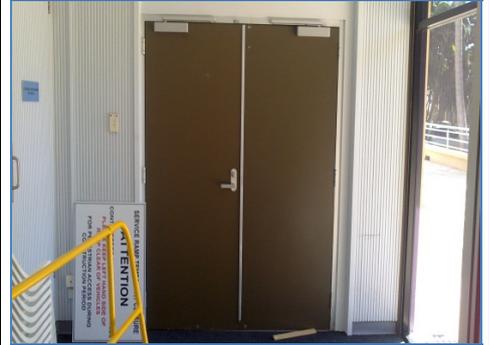
NORTHERN ENTRANCE FOYER		
Location	Type of Material	Condition
21. Fire doors (x2 sets), to Ground level Fire Control Panel Room (6m ²)	Not accessed or sampled. Based on past experience in similar areas, asbestos in some form may exist.	Stable Friable when exposed
Recommendation and Action		
It is recommended that if work is contemplated in this area, due care and diligence should be exercised Warning signs in place Refer Section 6.0: Management Procedures.

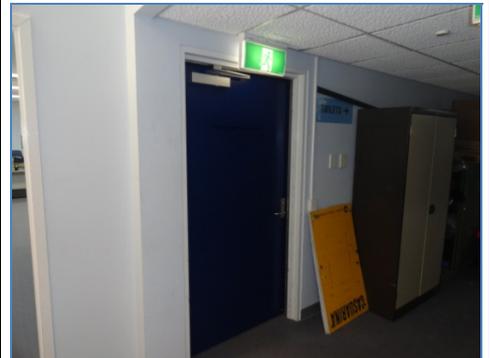
INTERNAL – LEVEL 1		
Location	Type of Material	Condition
22. Fire door, to North fire escape (2m ²)	Not accessed or sampled. Based on past experience in similar areas, asbestos in some form may exist.	Stable Friable when exposed
Recommendation and Action		
It is recommended that if work is contemplated in this area, due care and diligence should be exercised Warning signs in place Refer Section 6.0: Management Procedures.

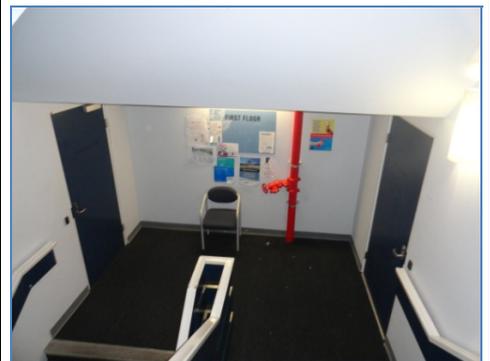
Location	Type of Material	Condition
23. Fire doors (x2), to main staircase landing (4m ²)	Not accessed or sampled. Based on past experience in similar areas, asbestos in some form may exist.	Stable Friable when exposed
Recommendation and Action		
It is recommended that if work is contemplated in this area, due care and diligence should be exercised Warning signs in place Refer Section 6.0: Management Procedures.

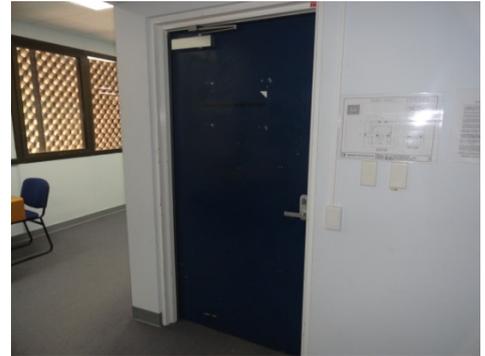
INTERNAL – LEVEL 2		
Location	Type of Material	Condition
24. Fire door, to North fire escape (2m ²)	Not accessed or sampled. Based on past experience in similar areas, asbestos in some form may exist.	Stable Friable when exposed
Recommendation and Action		
It is recommended that if work is contemplated in this area, due care and diligence should be exercised Warning signs in place Refer Section 6.0: Management Procedures.

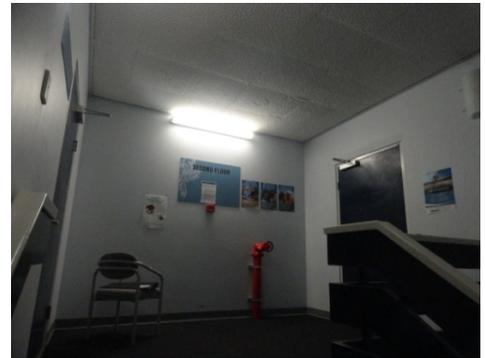
Location	Type of Material	Condition
25. Fire doors (x2), to main staircase landing (4m ²)	Not accessed or sampled. Based on past experience in similar areas, asbestos in some form may exist.	Stable Friable when exposed
Recommendation and Action		
It is recommended that if work is contemplated in this area, due care and diligence should be exercised Warning signs in place Refer Section 6.0: Management Procedures.

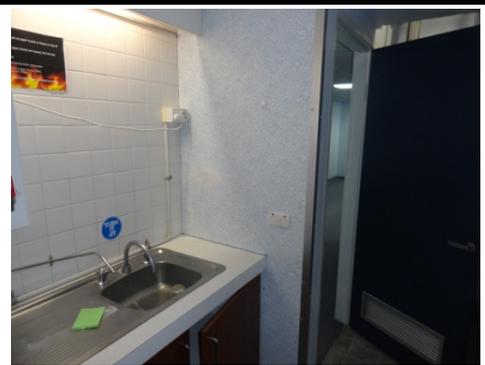
Location	Type of Material	Condition
26. Tilux sheeting to North wall of kitchen (2m ²)	Area accessed but not sampled. Based on findings in similar area, it is highly likely to contain asbestos.	Stable
Recommendation and Action		
Warning signs in place Refer Section 6.0: Management Procedures.

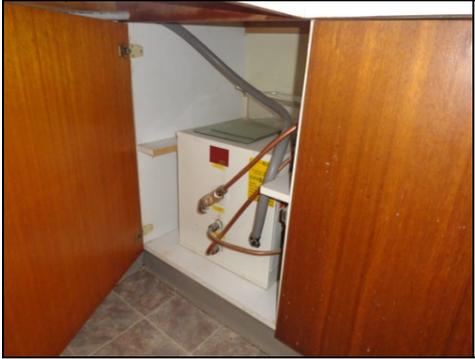
27. Insulation in Hot Water System within cupboard in kitchen (<1m ²)	Not accessed or sampled. Based on past experience in similar areas, asbestos in some form may exist.	Stable Friable when exposed	
<p>Recommendation and Action</p> <p>It is recommended that if work is contemplated in this area, due care and diligence should be exercised</p> <p>Warning signs in place</p> <p>Refer Section 6.0: Management Procedures.</p>
