**ASBESTOS REGISTER
NTB-01940
No. NT0545b
GOVERNMENT CENTRE
TENNANT CREEK NT**

**AEC Environmental Pty Ltd
Date: May 2013
Register No: NT0545b**

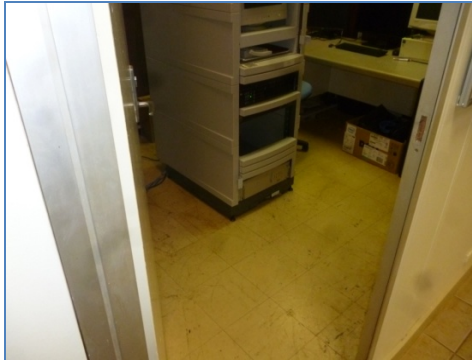
Location	Type of Material	Condition	
1. Floor covering in C9 Server room (8m ²)	Vinyl floor tiles containing white (Chrysotile) asbestos (sample no.1)	Stable

Recommendation and Action			
Warning signs: 2 small signs Refer Section 7.0: Management Procedures.

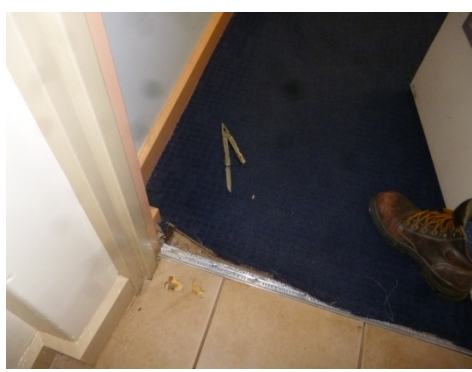
Location	Type of Material	Condition	
2. Floor covering under existing carpet in MVR back office (extent unknown) Sample taken from Door to Toilet area at D1	Vinyl floor tiles containing white (Chrysotile) asbestos (sample no.2)	Stable

Recommendation and Action			
Warning signs: 4 small signs Refer Section 7.0: Management Procedures.

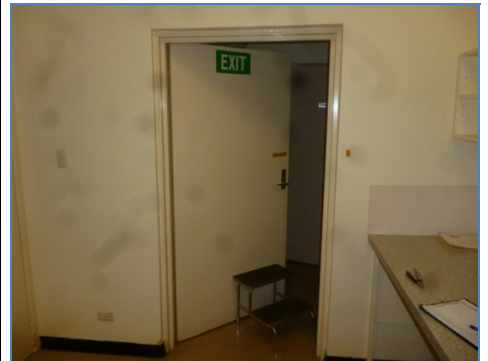
OLD DEPARTMENT of CORRECTIONS - Internal		
Location	Type of Material	Condition
3. Exit door in E4 Kitchenette (3m ²)	Core material containing white (Chrysotile) & grey/brown (Amosite) asbestos (sample no.5)	Friable Exposed at top & possibly bottom
Recommendation and Action		
Encapsulate or Remove		
Warning signs: 2 small signs Refer Section 7.0: Management Procedures.

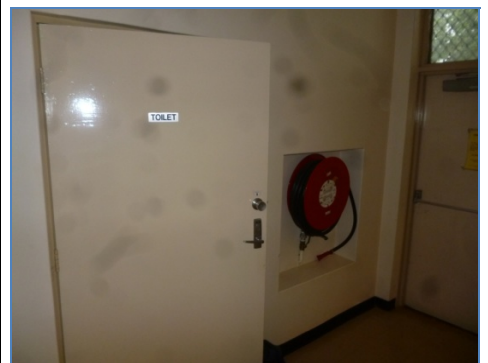
Location	Type of Material	Condition
4. Toilet door at C2, adjacent to Fire Exit (3m ²)	Core material containing white (Chrysotile) & grey/brown (Amosite) asbestos (per sample no.5)	Friable Exposed at top & possibly bottom
Recommendation and Action		
Encapsulate or Remove		
Warning signs: 2 small signs Refer Section 7.0: Management Procedures.

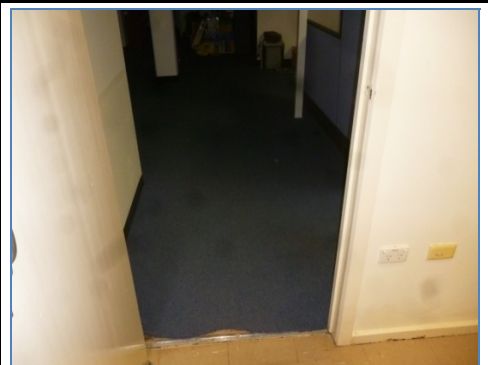
Location	Type of Material	Condition
5. Floor covering under existing carpet throughout Western elevation office space (60m ²)	Vinyl floor tiles containing white (Chrysotile) asbestos (sample no.6)	Stable
Recommendation and Action		
Warning signs: 5 small signs Refer Section 7.0: Management Procedures

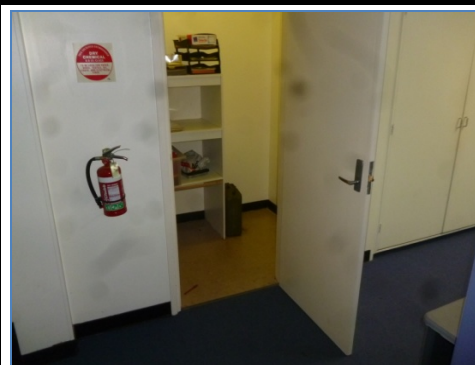
OLD DEPARTMENT of CORRECTIONS – Internal (cont'd)		
Location	Type of Material	Condition
6. Floor covering in side Store room, C1 (3m ³)	Vinyl floor tiles containing white (Chrysotile) asbestos (per sample no.6)	Stable
Recommendation and Action		
Warning signs: 1 small signs Refer Section 7.0: Management Procedures

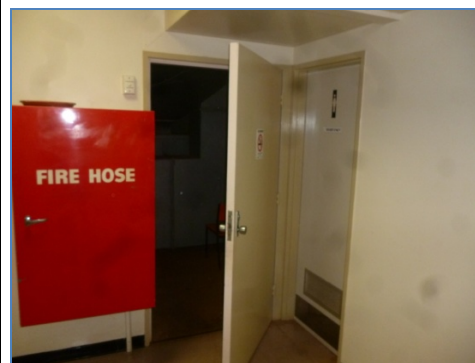
FIRST FLOOR - Internal		
Location	Type of Material	Condition
7. Door to A5 AC Plant room (3m ²)	Core material containing white (Chrysotile) & grey/brown (Amosite) asbestos (sample no.7)	Friable Exposed at top & possibly bottom
Recommendation and Action		
Encapsulate or Remove Warning signs: 2 small signs Refer Section 7.0: Management Procedures.

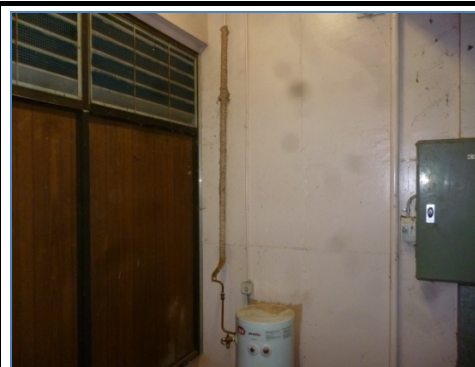
Location	Type of Material	Condition
8. Lagging around pipe connected to HWS in A5 AC Plant room (2 lineal meters)	Woven rope material containing white (Chrysotile) asbestos (sample no.8)	Friable
Recommendation and Action		
Remove Section 7.0: Management Procedures

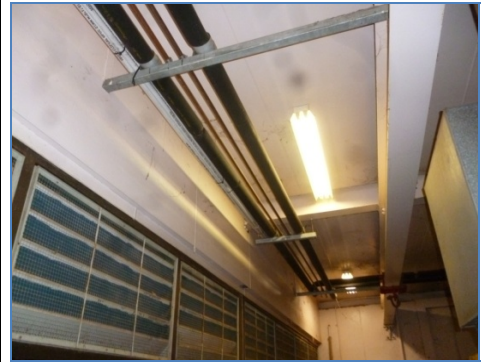
FIRST FLOOR – Internal (cont'd)		
Location	Type of Material	Condition
9. High infill panels to ceiling & Southern elevation wall in A5 AC Plant room (90m ²)	Fibre cement sheet material containing white (Chrysotile) asbestos (sample no.9)	Stable
Recommendation and Action		
Warning signs: 4 small signs Refer Section 7.0: Management Procedures

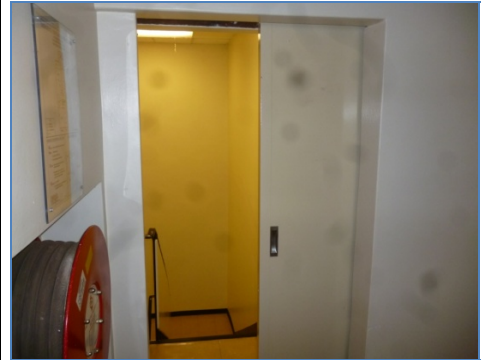
Location	Type of Material	Condition
10. Fire door at the top of Fire Escape stairs. C6 (2m ²)	Not accessed or sampled. Based on past experience in similar areas, asbestos in some form may exist. It is recommended that if work is contemplated in this area, due care & diligence should be exercised	Friable When Wet
Recommendation and Action		
Warning signs: 2 small signs Refer Section 6.0: Management Procedures.

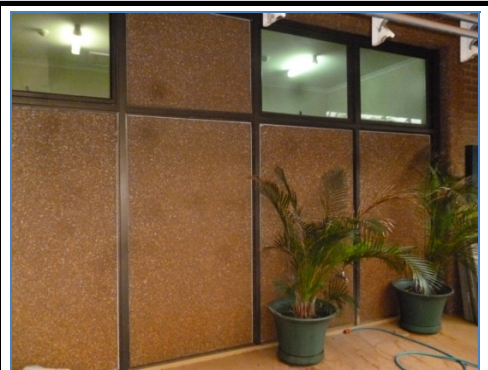
EXTERNAL		
Location	Type of Material	Condition
11. Wall panels with stone coating, throughout (120m ²)	Fibre cement sheet material containing white (Chrysotile) asbestos (sample no.10)	Stable
Recommendation and Action		
Warning sign: 1 General Awareness sign Refer Section 7.0: Management Procedures

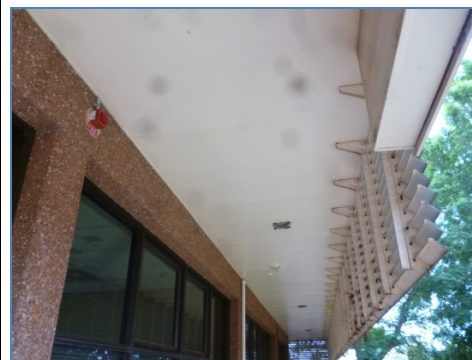
EXTERNAL- (cont'd)		
Location	Type of Material	Condition
12. Eave cladding throughout (220m ²) No access due to height restriction.	Not accessed or sampled. Based on past experience in similar areas, asbestos in may exist. It is recommended that if work is contemplated in this area, due care & diligence should be exercised.	Stable
Recommendation and Action		
Warning signs: 20 small signs Refer Section 7.0: Management Procedures

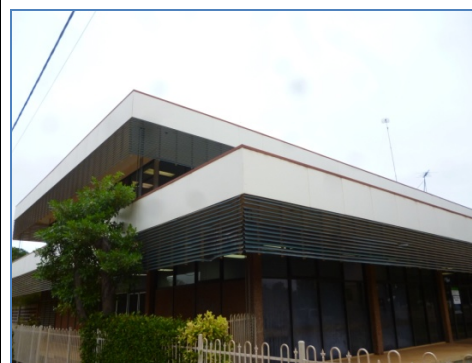
Location	Type of Material	Condition
13. High fascia panels throughout (300m ²) No access due to height restriction.	Not accessed or sampled. Based on past experience in similar areas, asbestos may exist. It is recommended that if work is contemplated in this area, due care & diligence should be exercised.	Stable
Recommendation and Action		
Warning signs: 16 small signs Refer Section 7.0: Management Procedures
